HELICOPTER SECONDARY STRUCTURES
RELIABILITY AND MAINTAINABILITY
INVESTIGATION

Kenneth B. Krieger

United Aircraft Corporation

July 1974

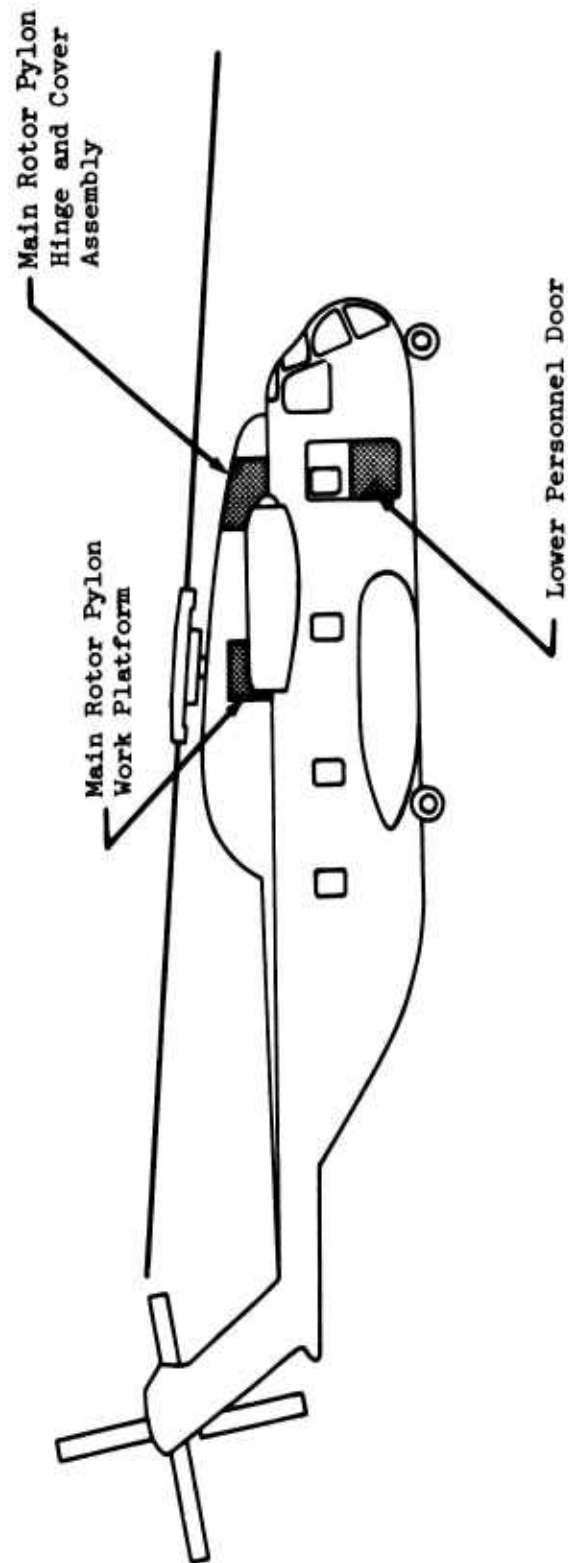
Figure 1. S-65 Secondary Structure Test Articles.

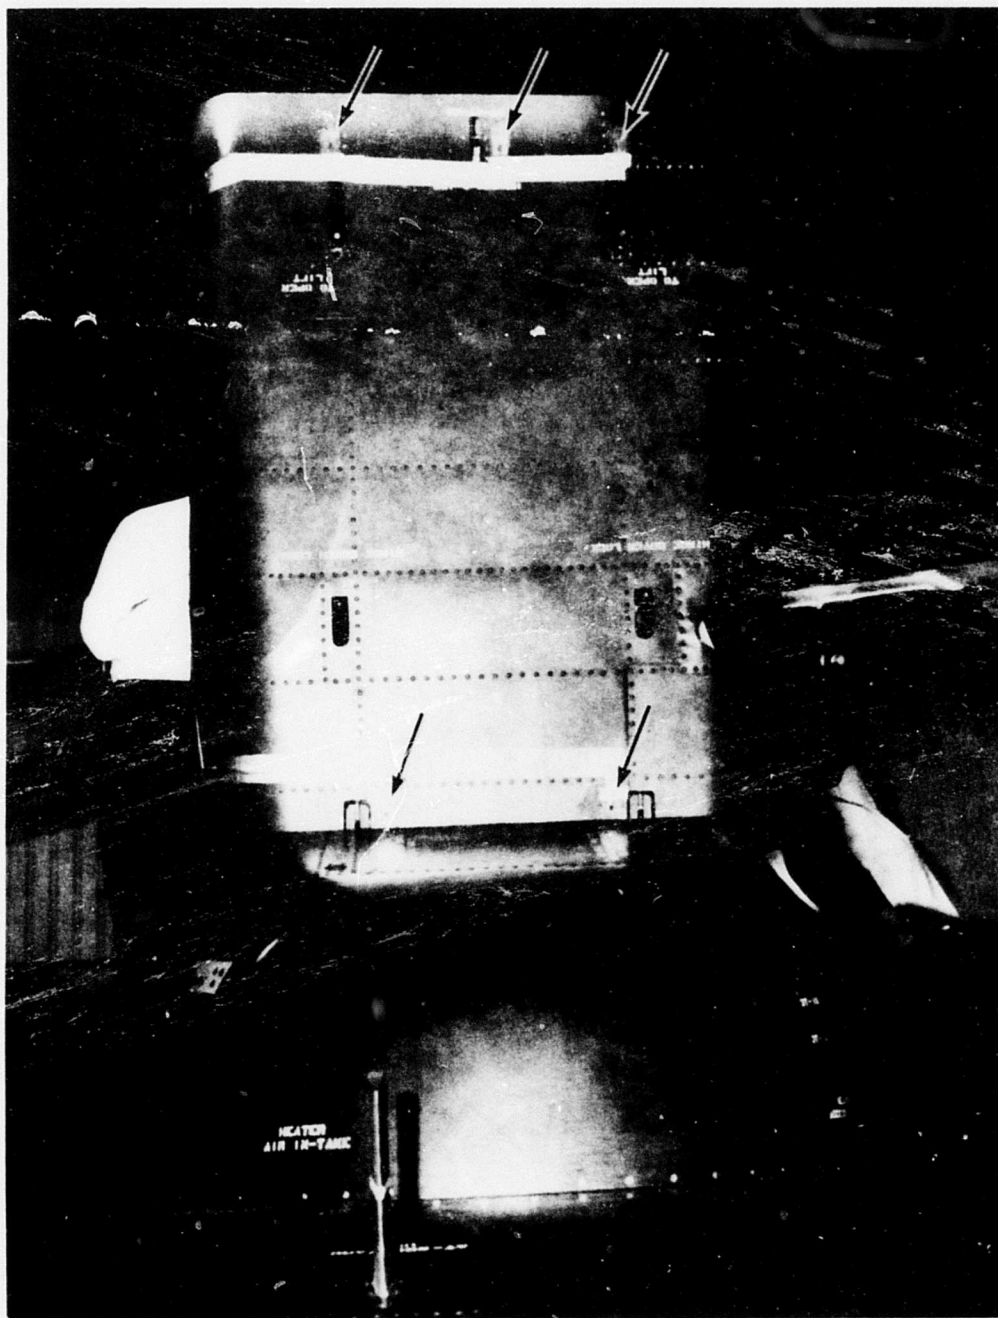
Figure 2. Flight Vibratory Load Survey, Strain Gage Locations, Hinged Cover.

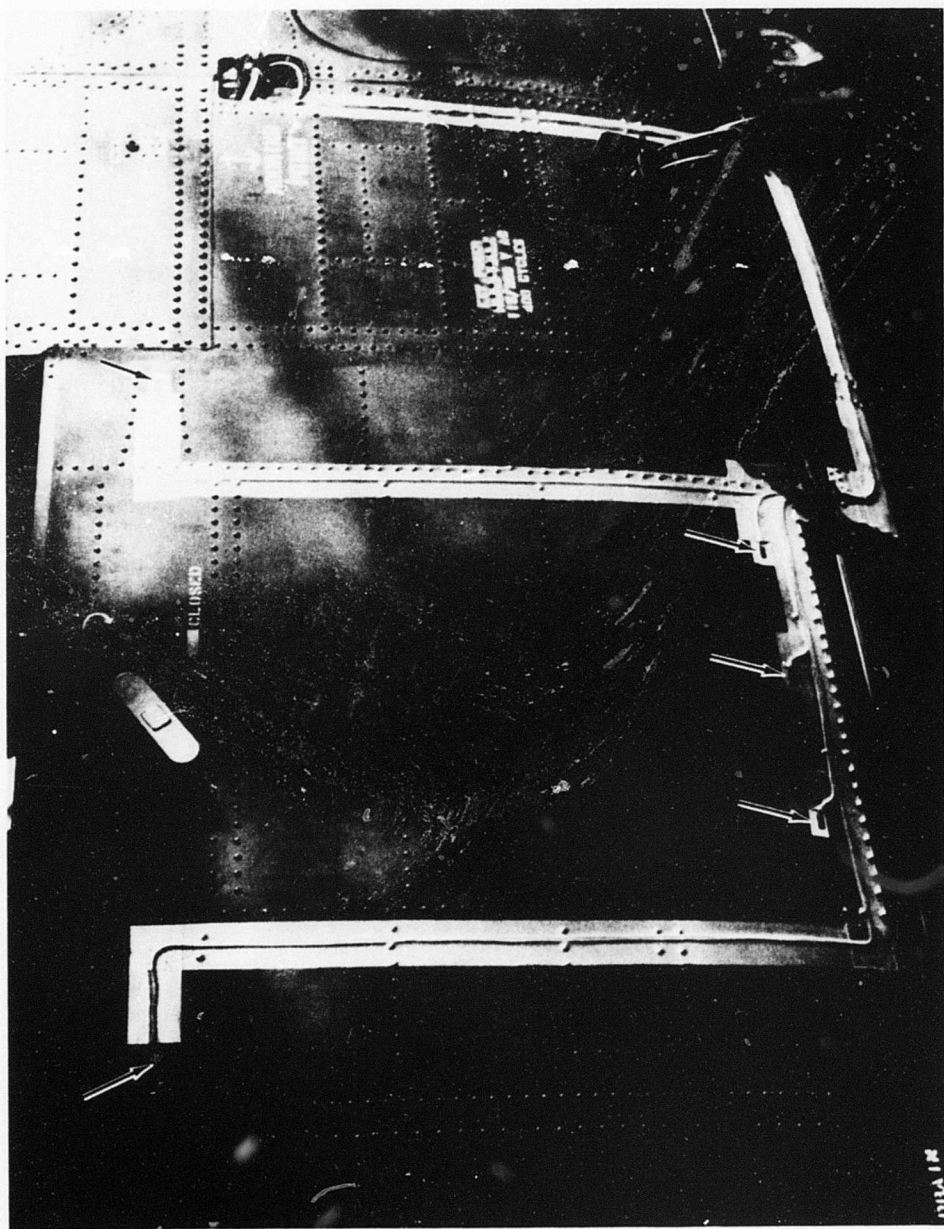
Figure 3. Flight Vibratory Load Survey, Strain Gage Locations, Personnel Door.

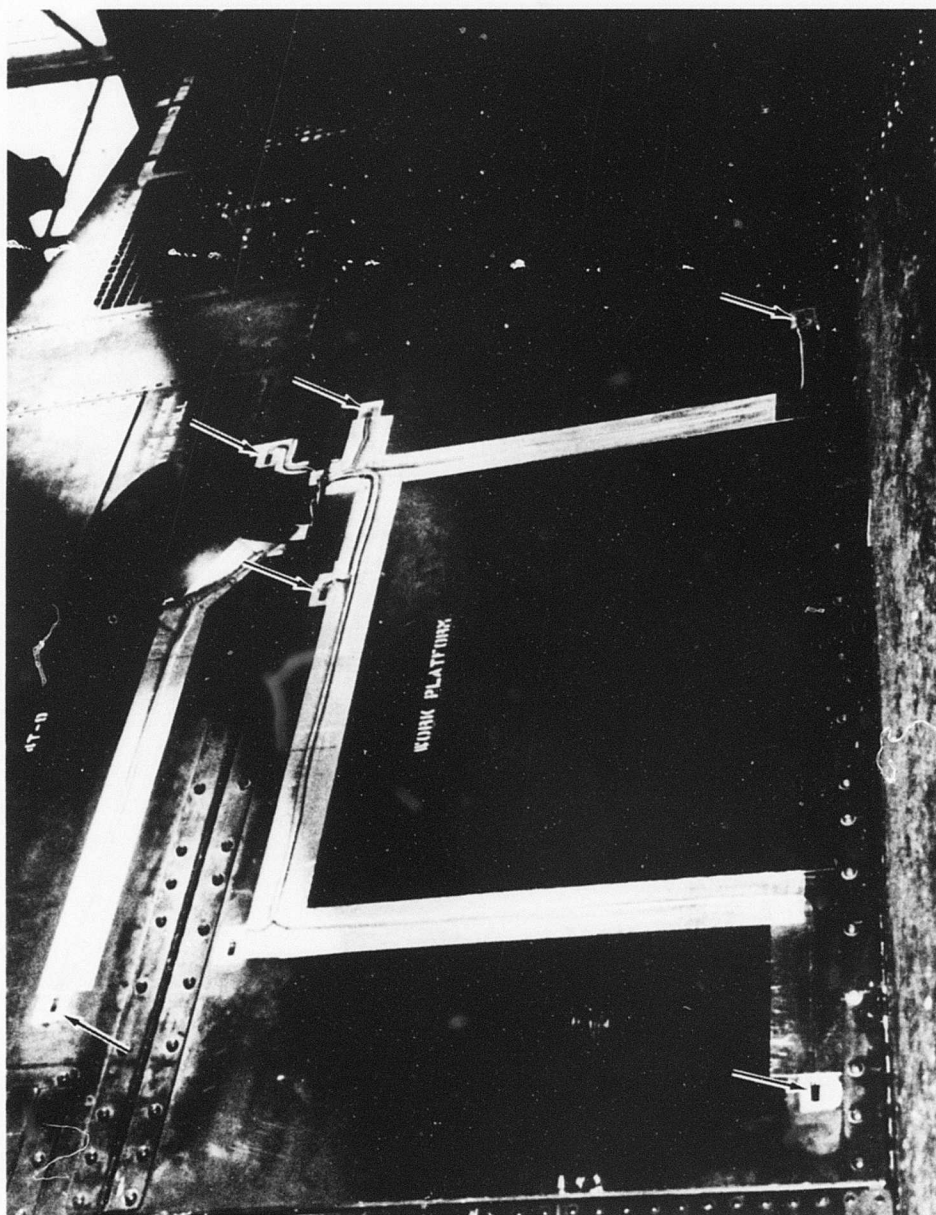
Figure 4. Flight Vibratory Load Survey, Strain Gage Locations, Work Platform.

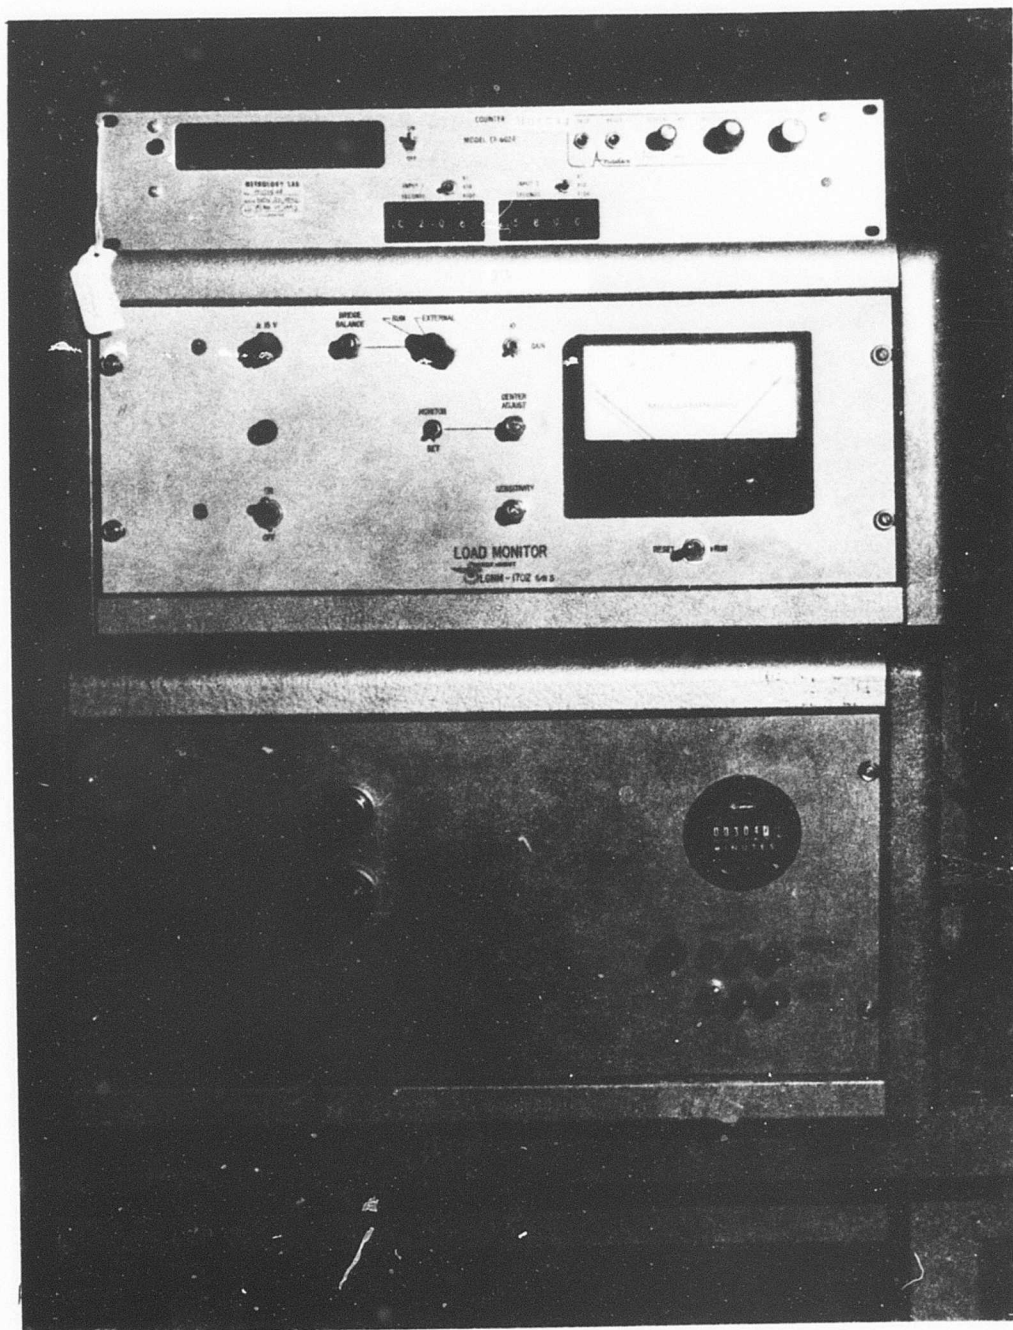
Figure 5. Vibratory Load, Instrumentation.

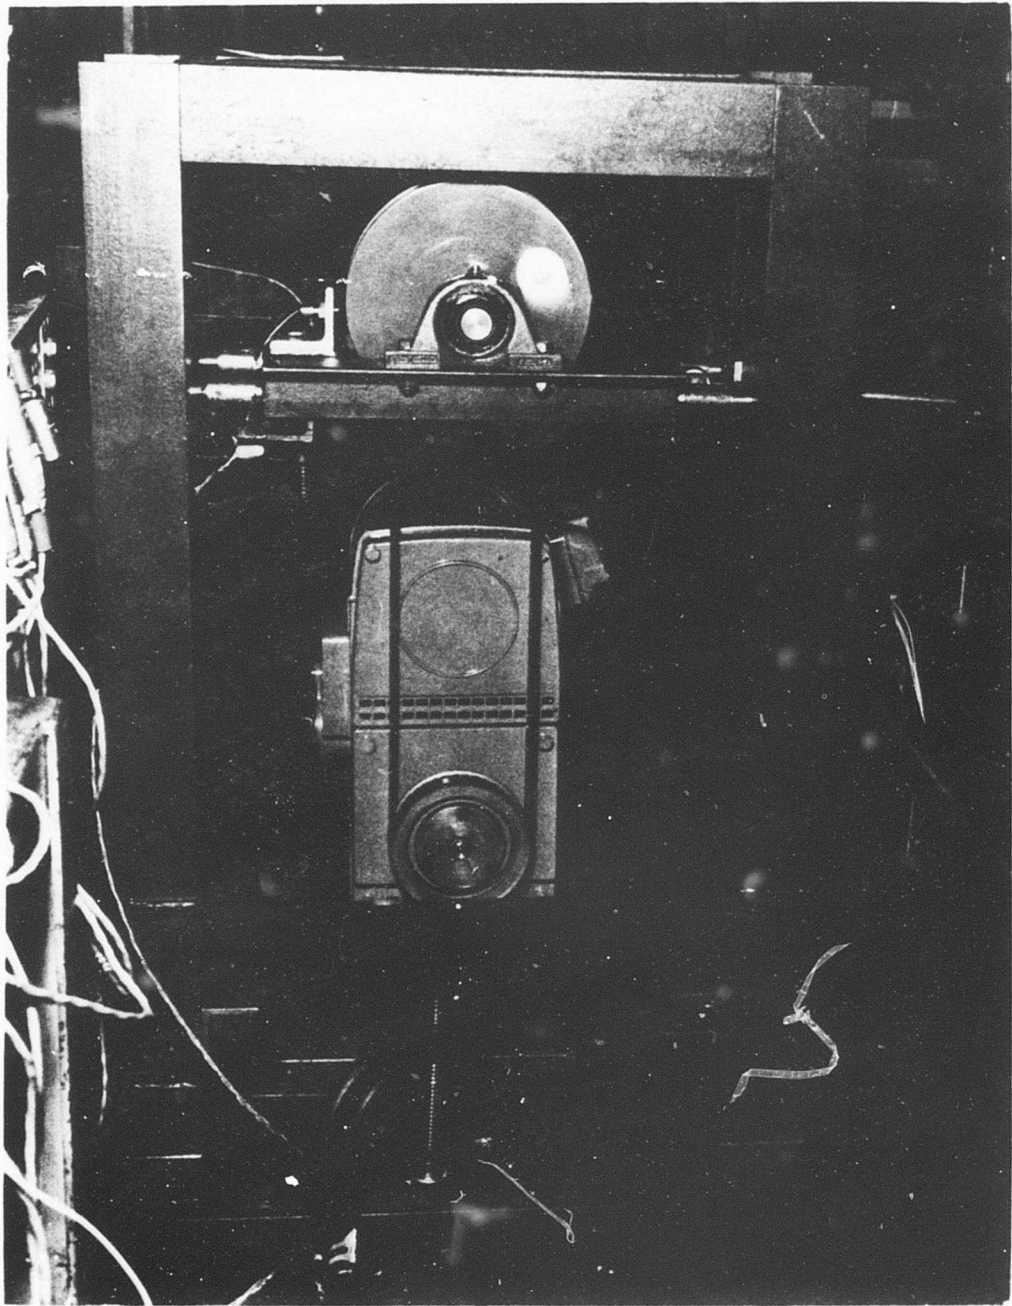
Figure 6. Vibratory Load, Varidrive Motor and Wheel and Carriage Assembly.

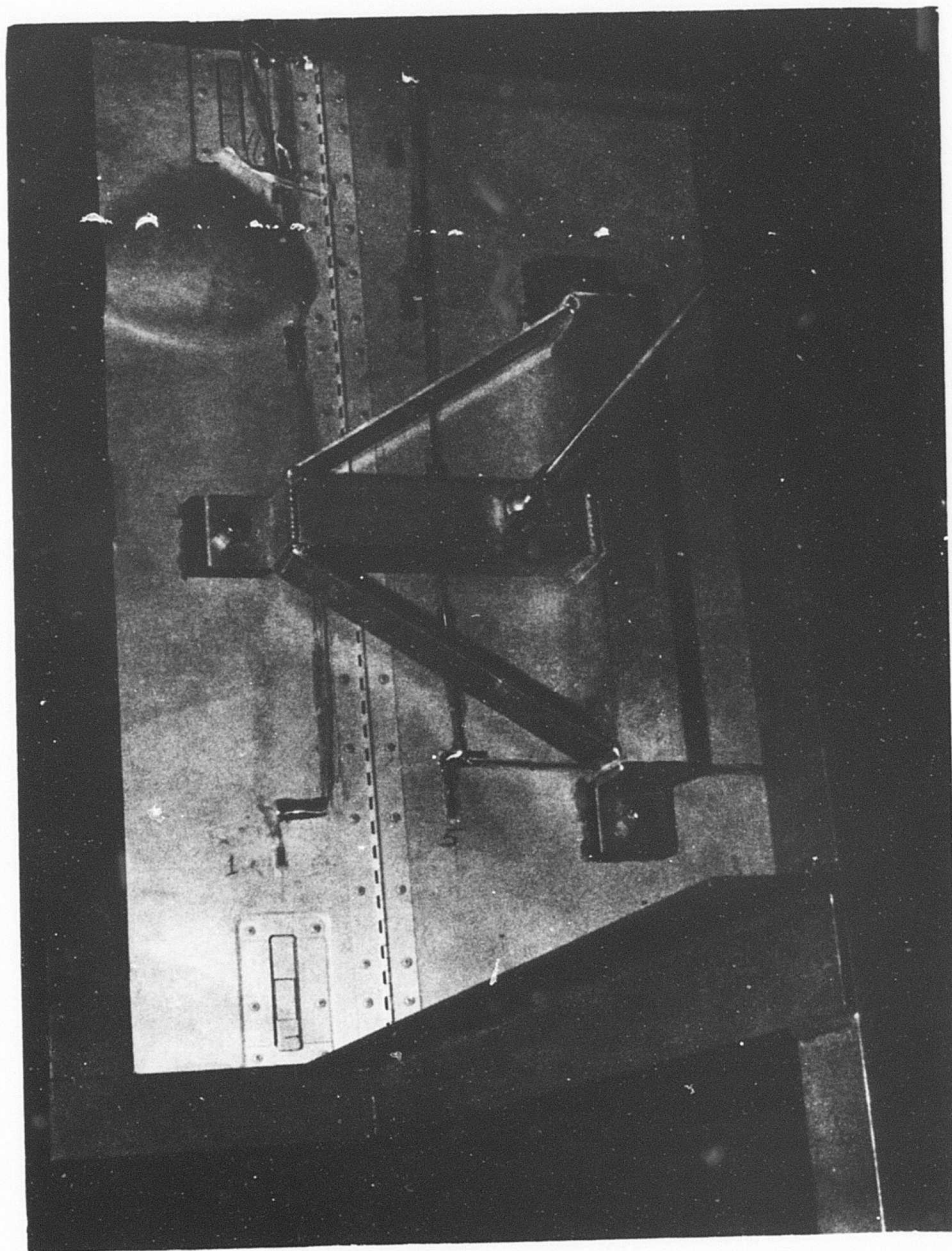
Figure 7. Vibratory Load, Load Frame.

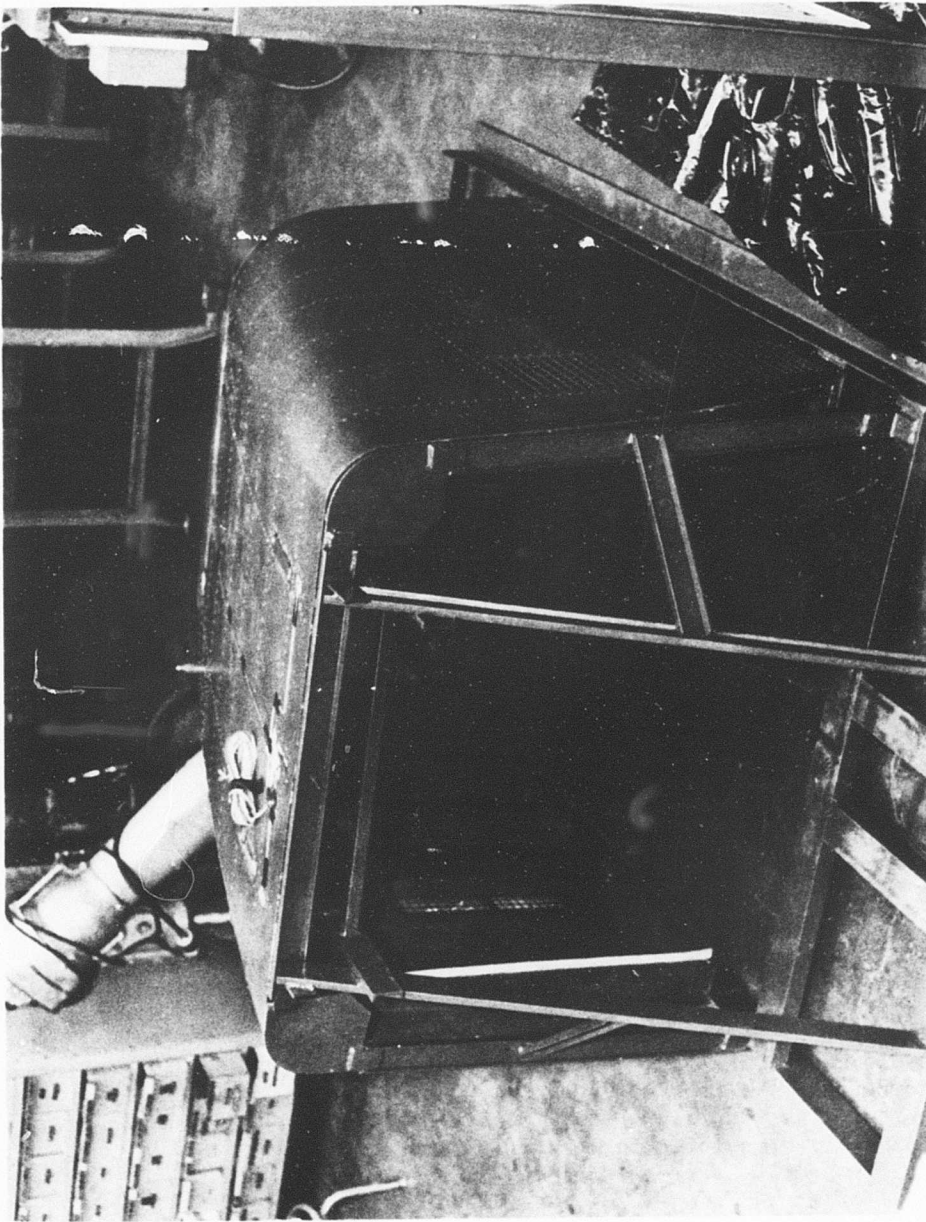
Figure 12. Main Rotor Pylon, Hinged Cover Assembly.

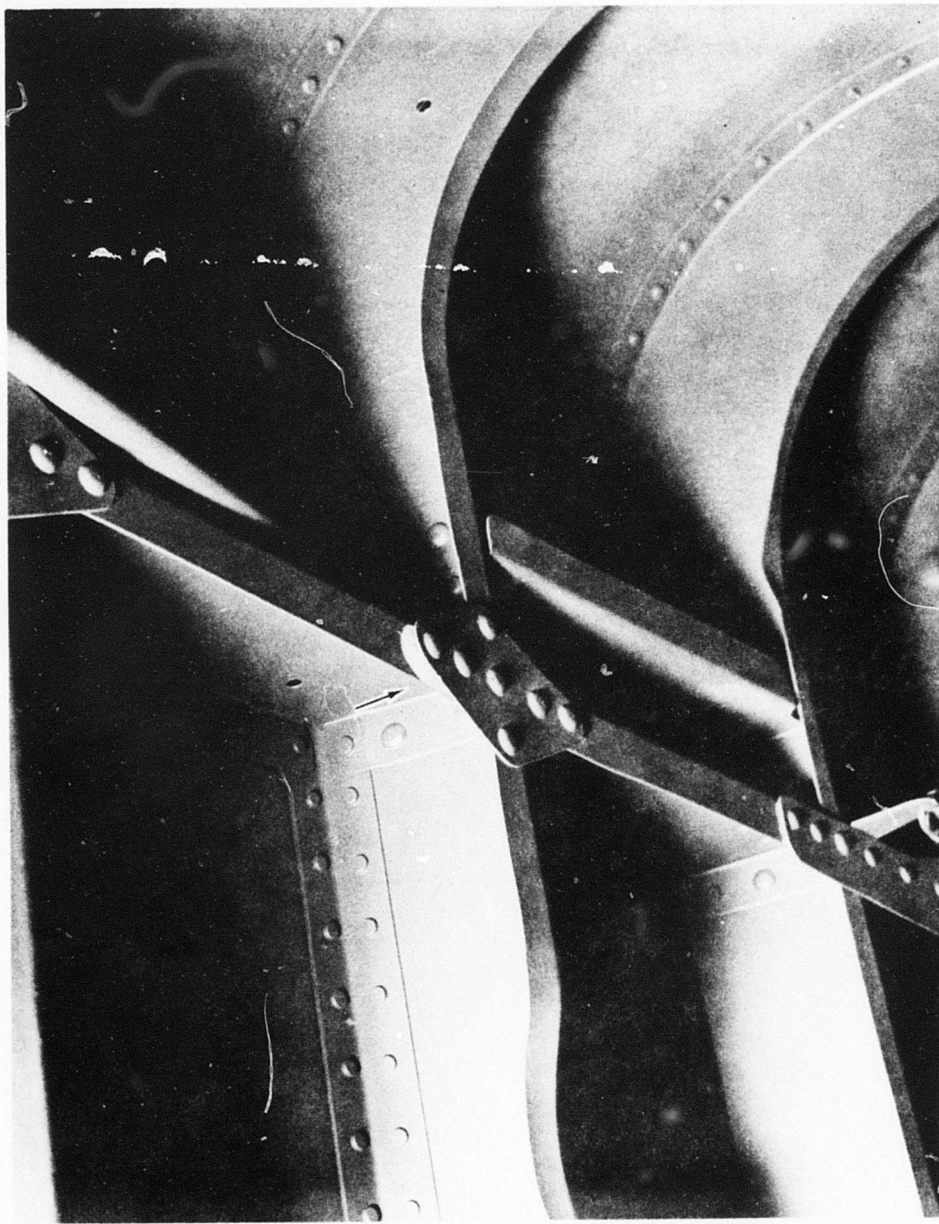
Figure 17. Main Rotor Pylon, Structural Damage, Popped Rivets.

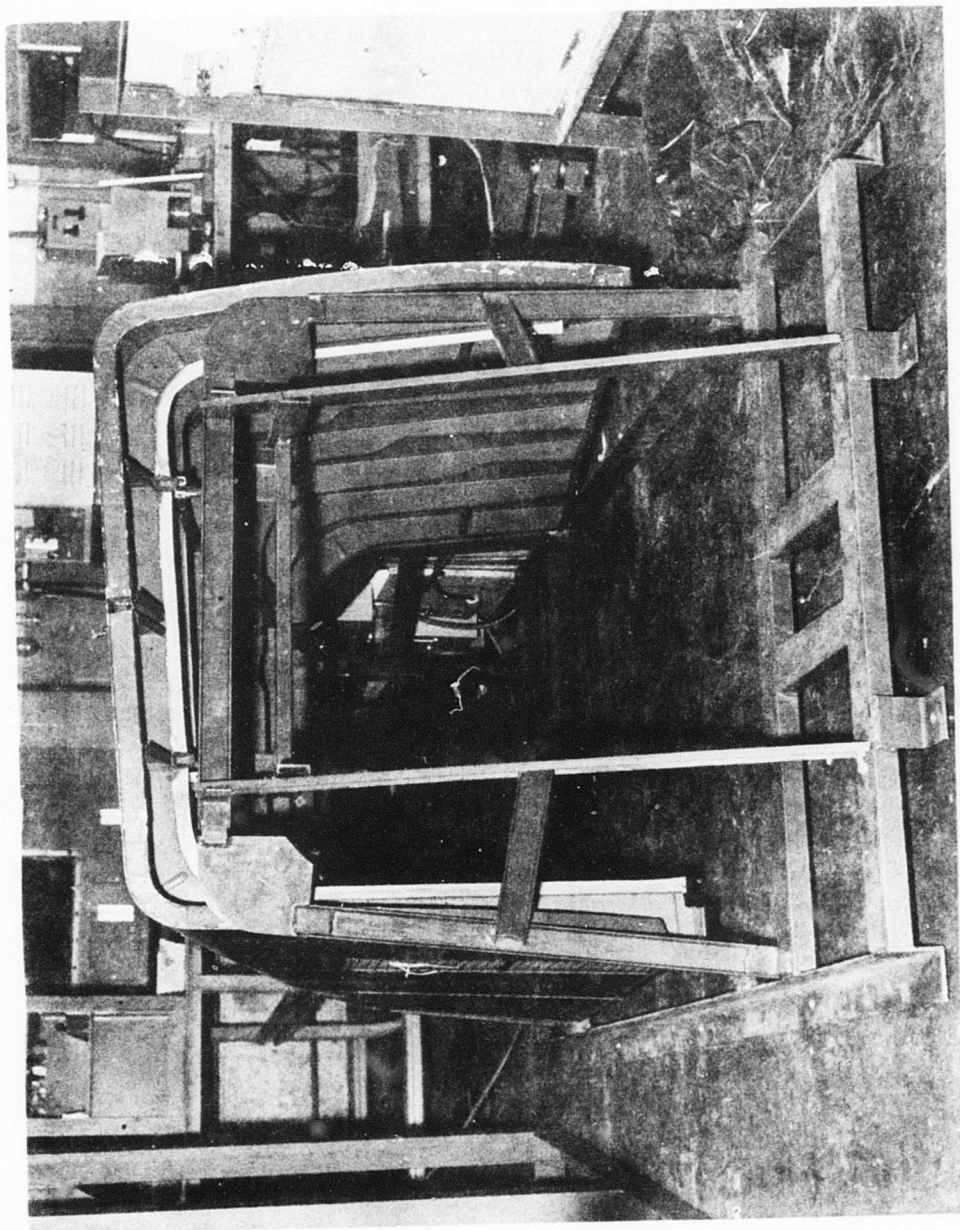
Figure 21. Main Rotor Pylon, Misalignment.

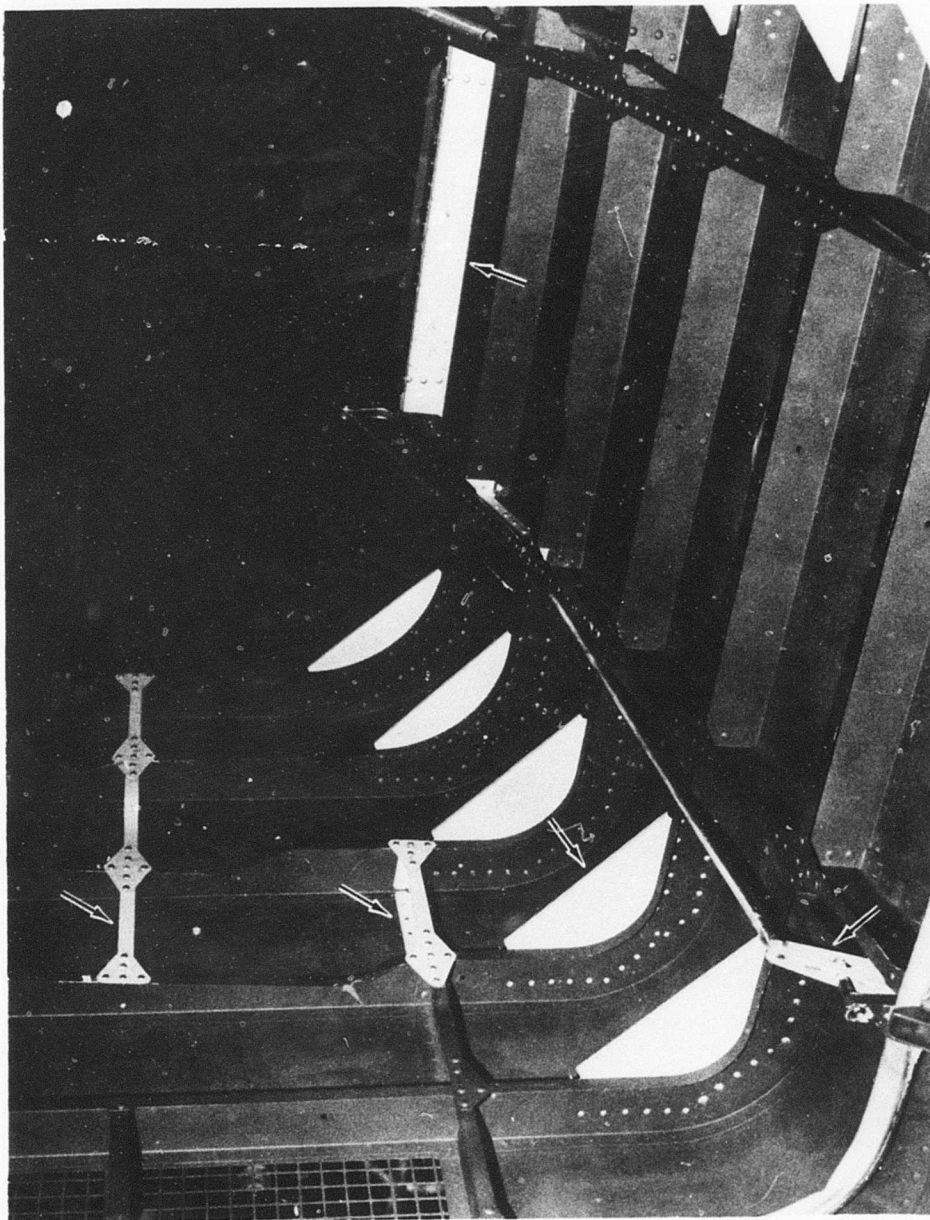
Figure 22. Main Rotor Pylon, Redesign.

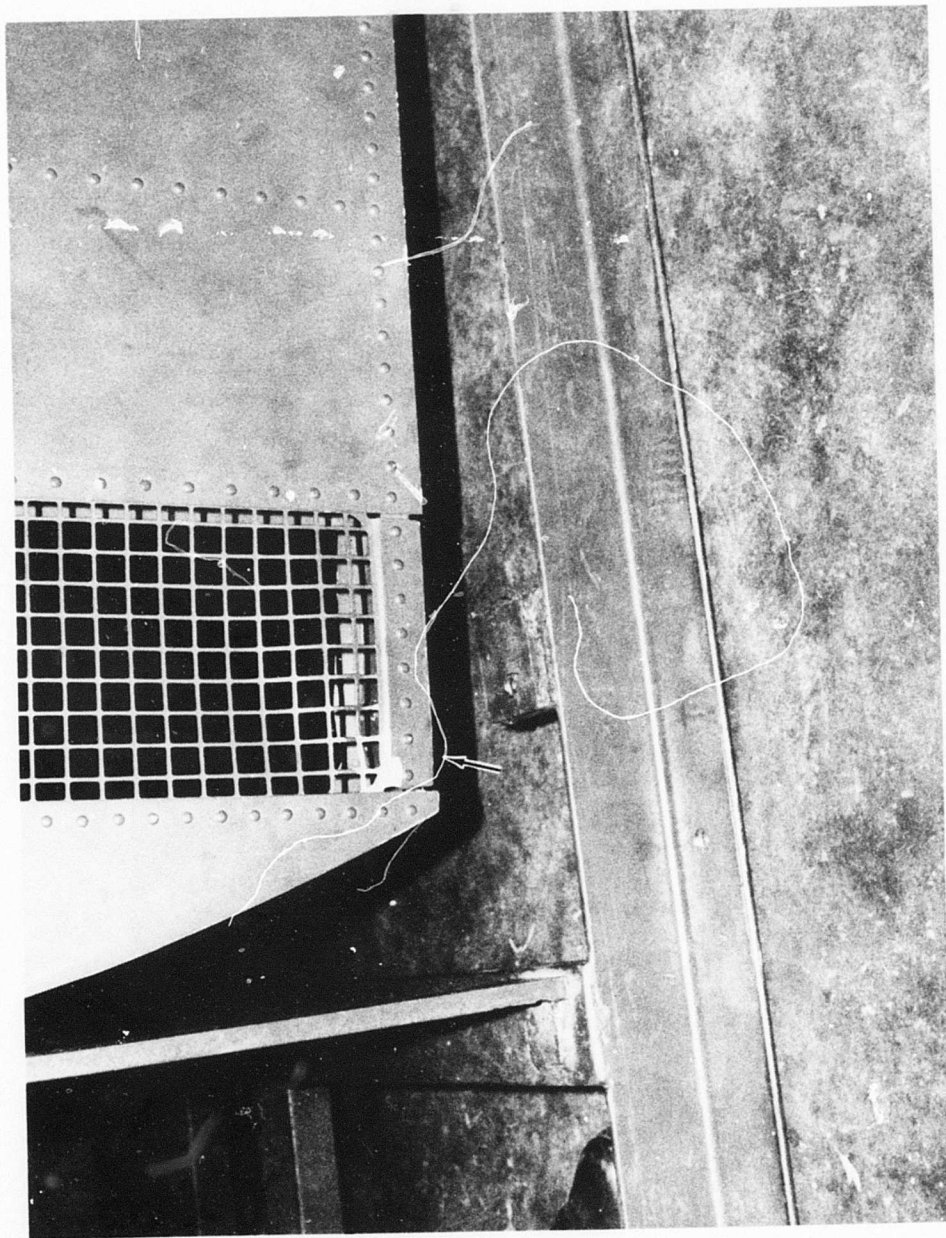
Figure 23. Main Rotor Pylon, Redesign, Alignment Pin Mount.

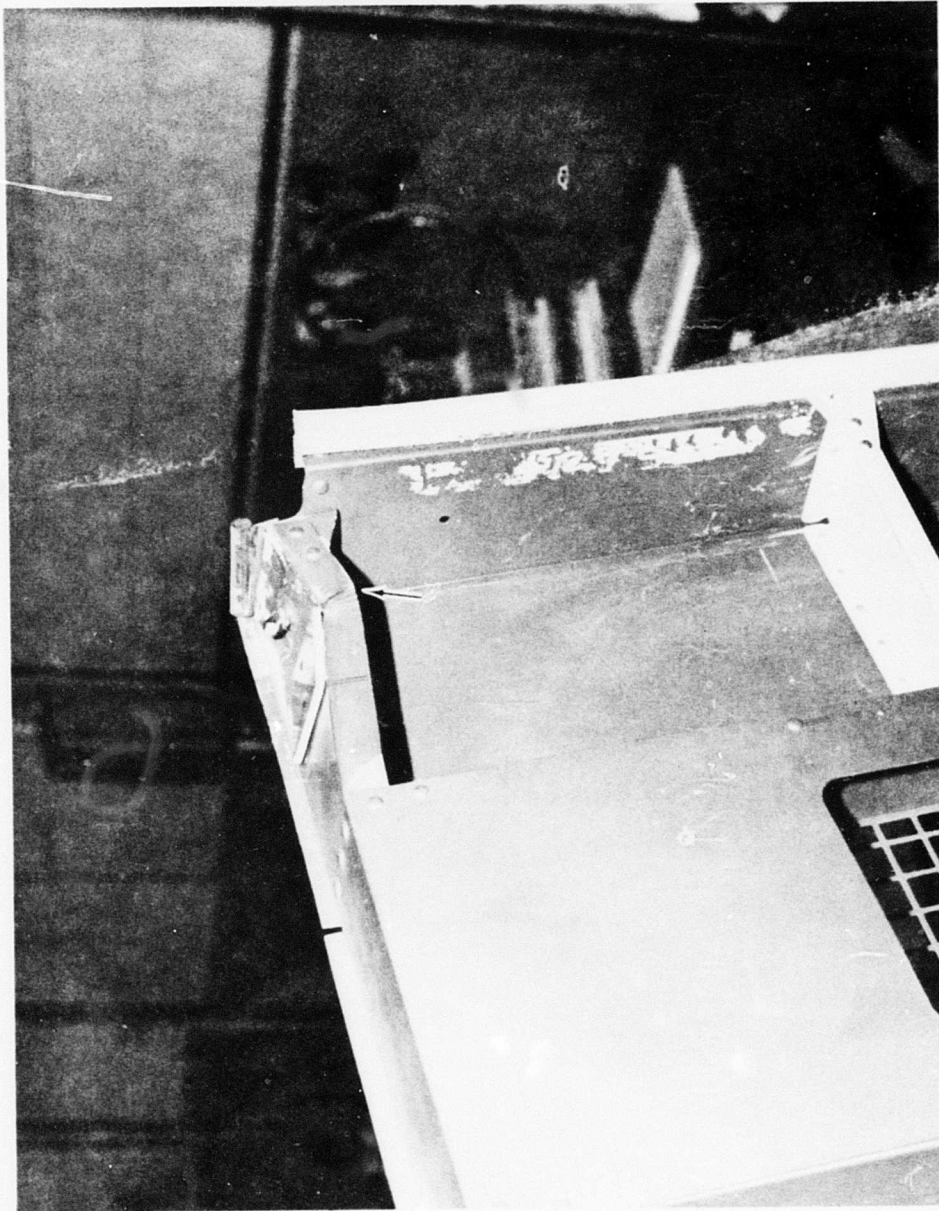
Figure 24. Main Rotor Pylon, Redesign, Alignment Pin Mount Damage.

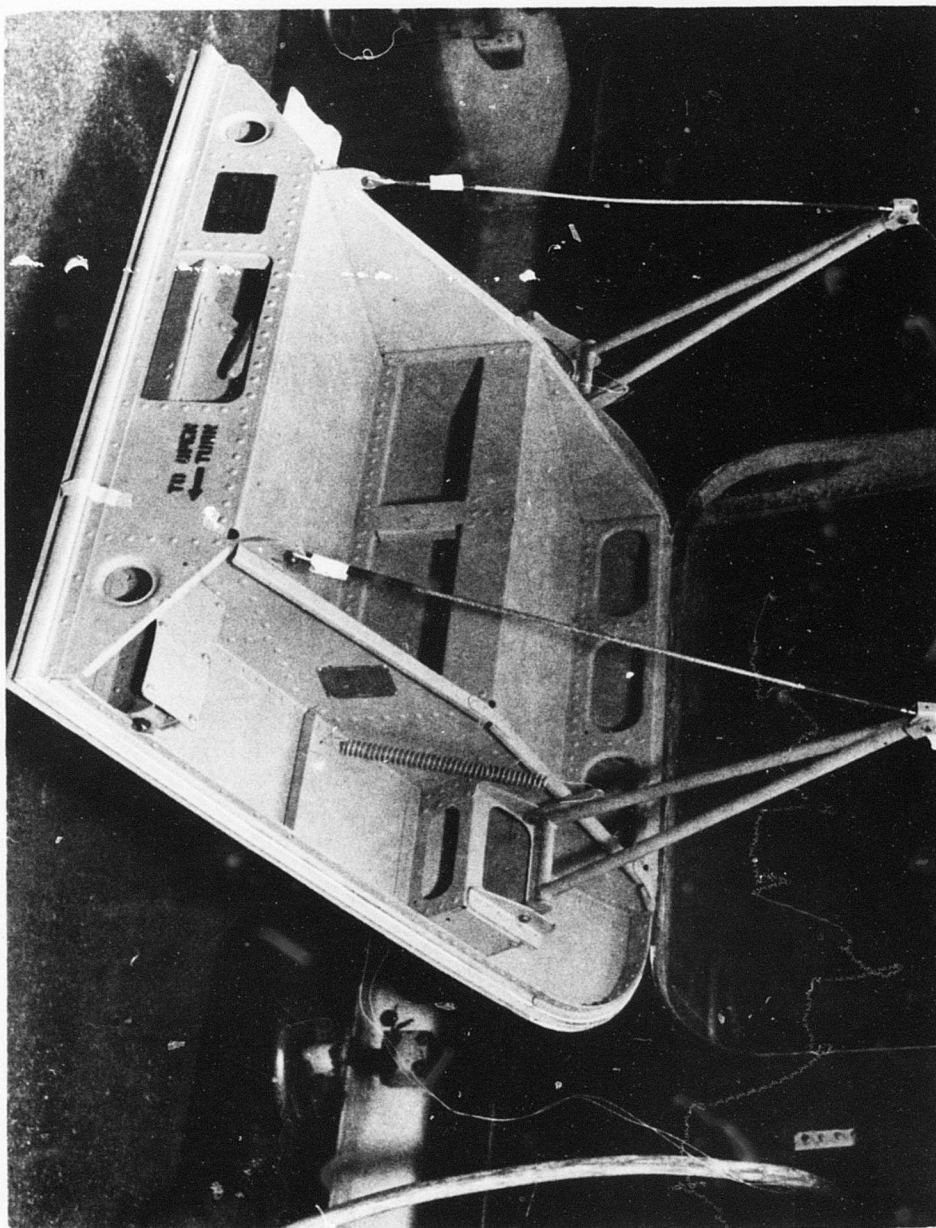
Figure 25. Lower Personnel Door.

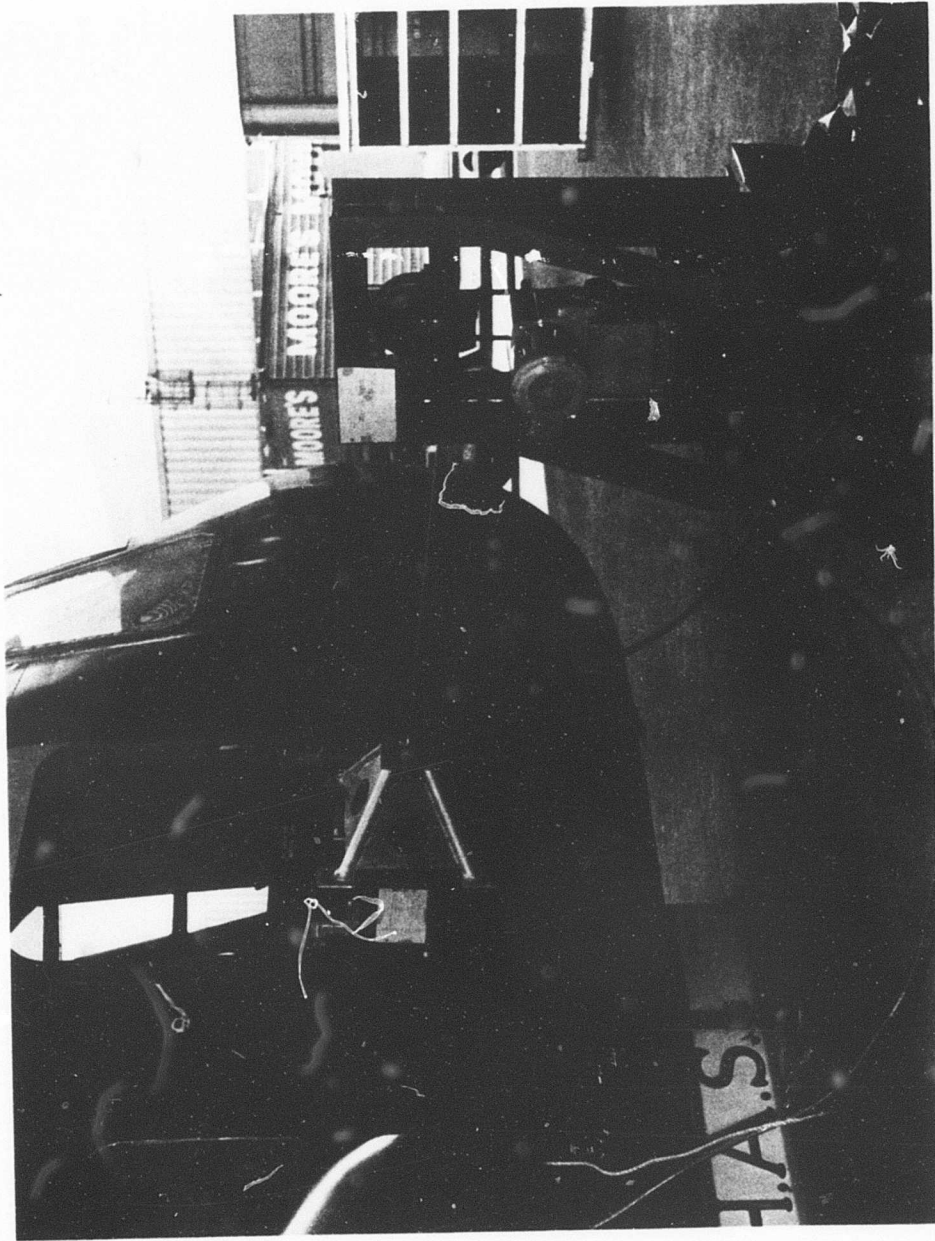
Unlike the other two test items, the vibratory loading on the door (Figure 27) resulted in fatigue cracks similar to field modes. The original design lower personnel door developed the cracks in the skin through the support

Figure 27. Lower Personnel Door, Vibratory Load Test Setup.

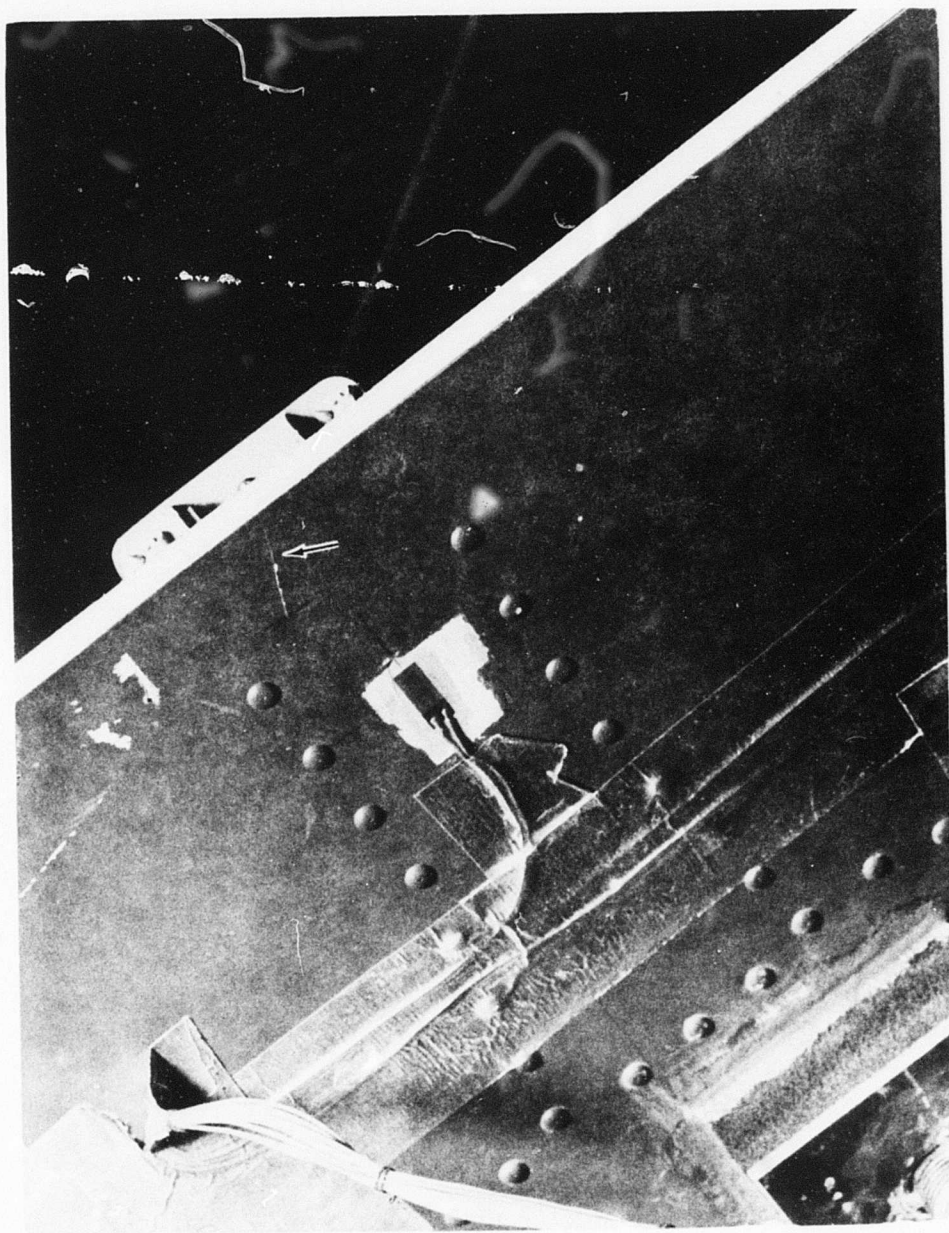
channels (Figures 28 and 29) at the latches in 175 hours of running. The redesigned door showed improvement. Although the same type of cracks appeared, they took longer (252 hours) and were smaller, not propagating as quickly.

Figure 28. Lower Personnel Door, Original, Fatigue Skin Crack.

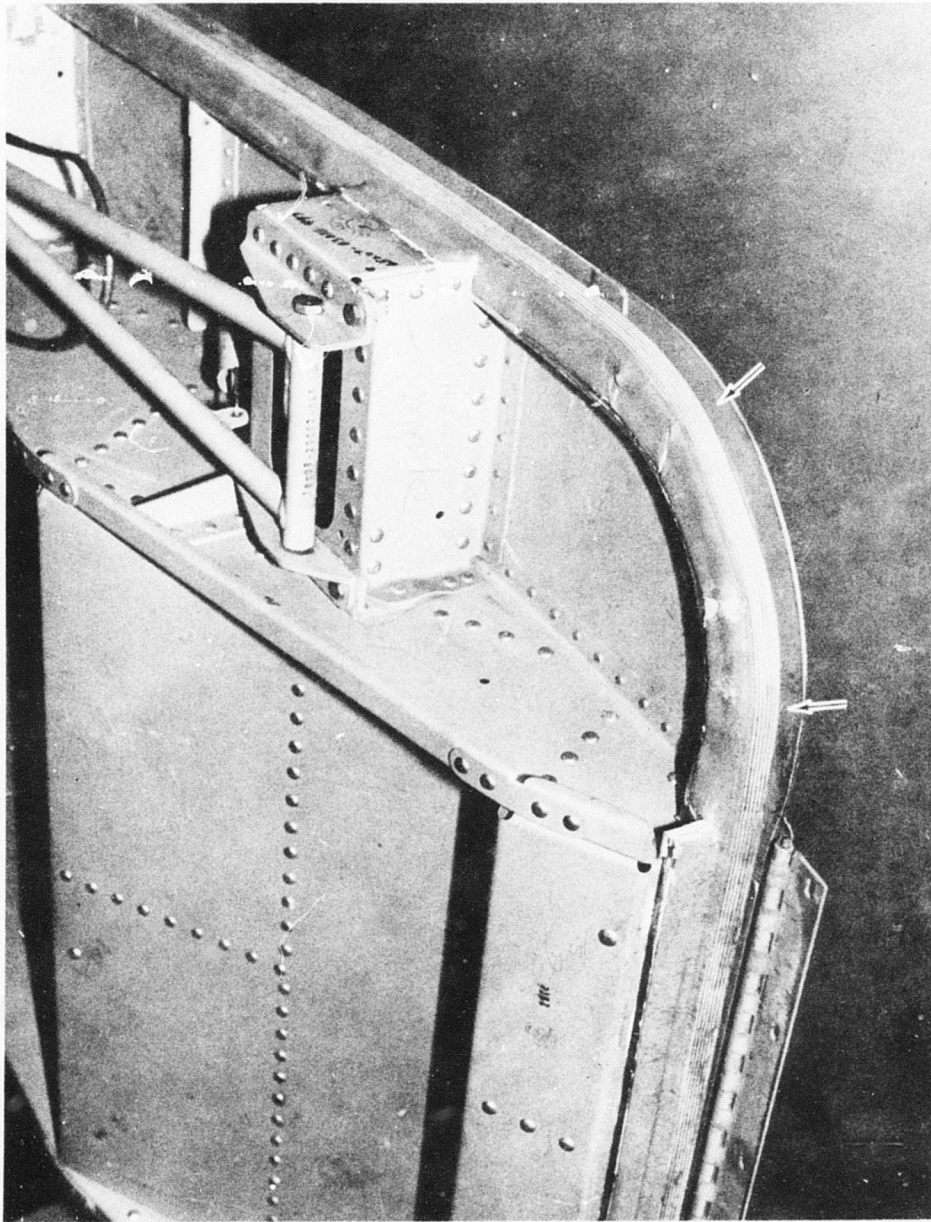
Figure 30. Lower Personnel Door, Redesign, Improved Seal.

The redesigned cable support, -043, is shown in detail in Figure 11. The bottom attachment is changed to accept one long through bolt (Figure 30) for a more solid support. The previous installation (Figure 31) had two short bolts which "wracked" from eccentric lug loading. The installation attachment is strengthened (see zone 2B, section D-D, Figure 10) by replacing end rivets with a bolt and radius block.

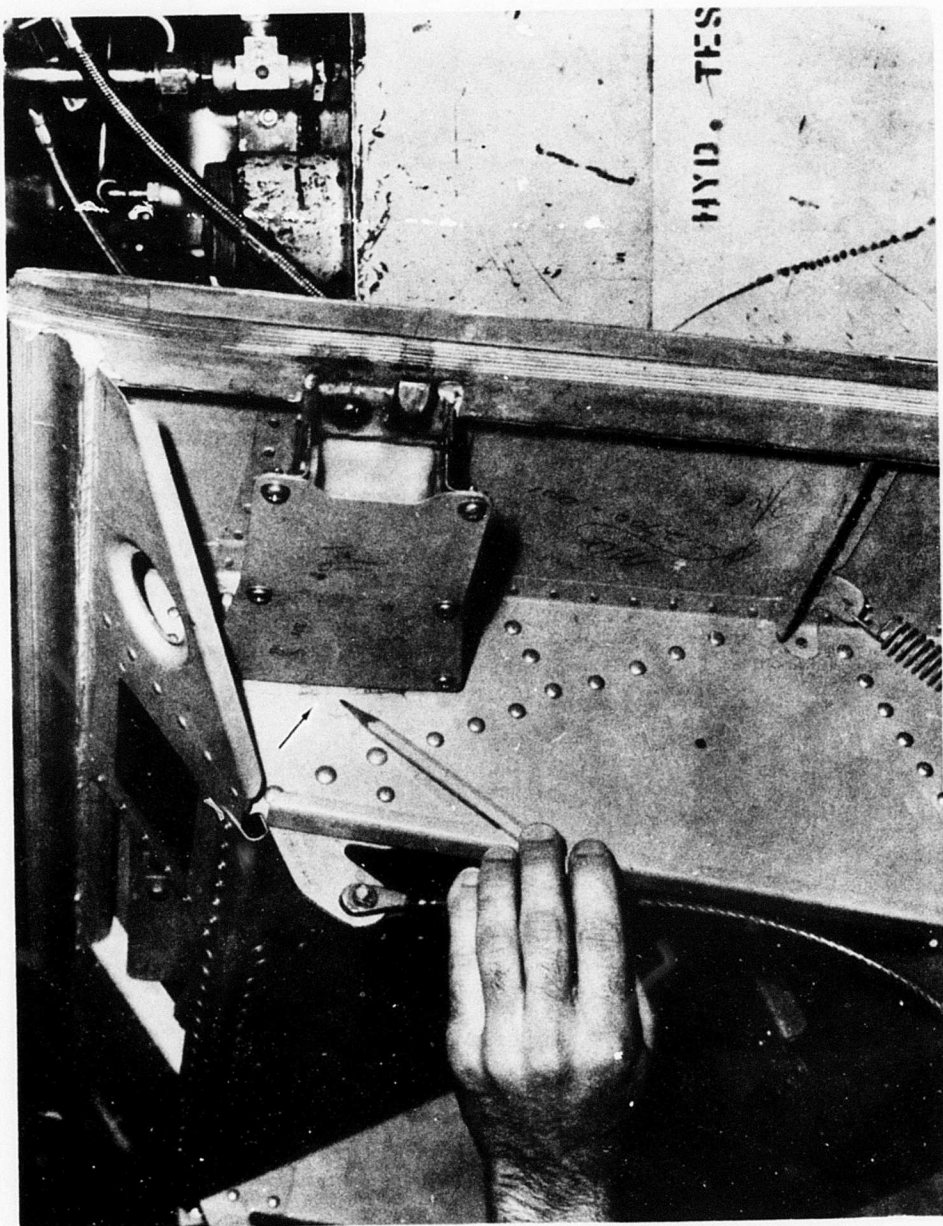
Figure 32. Lower Personnel Door, Side Beam Fatigue Crack.

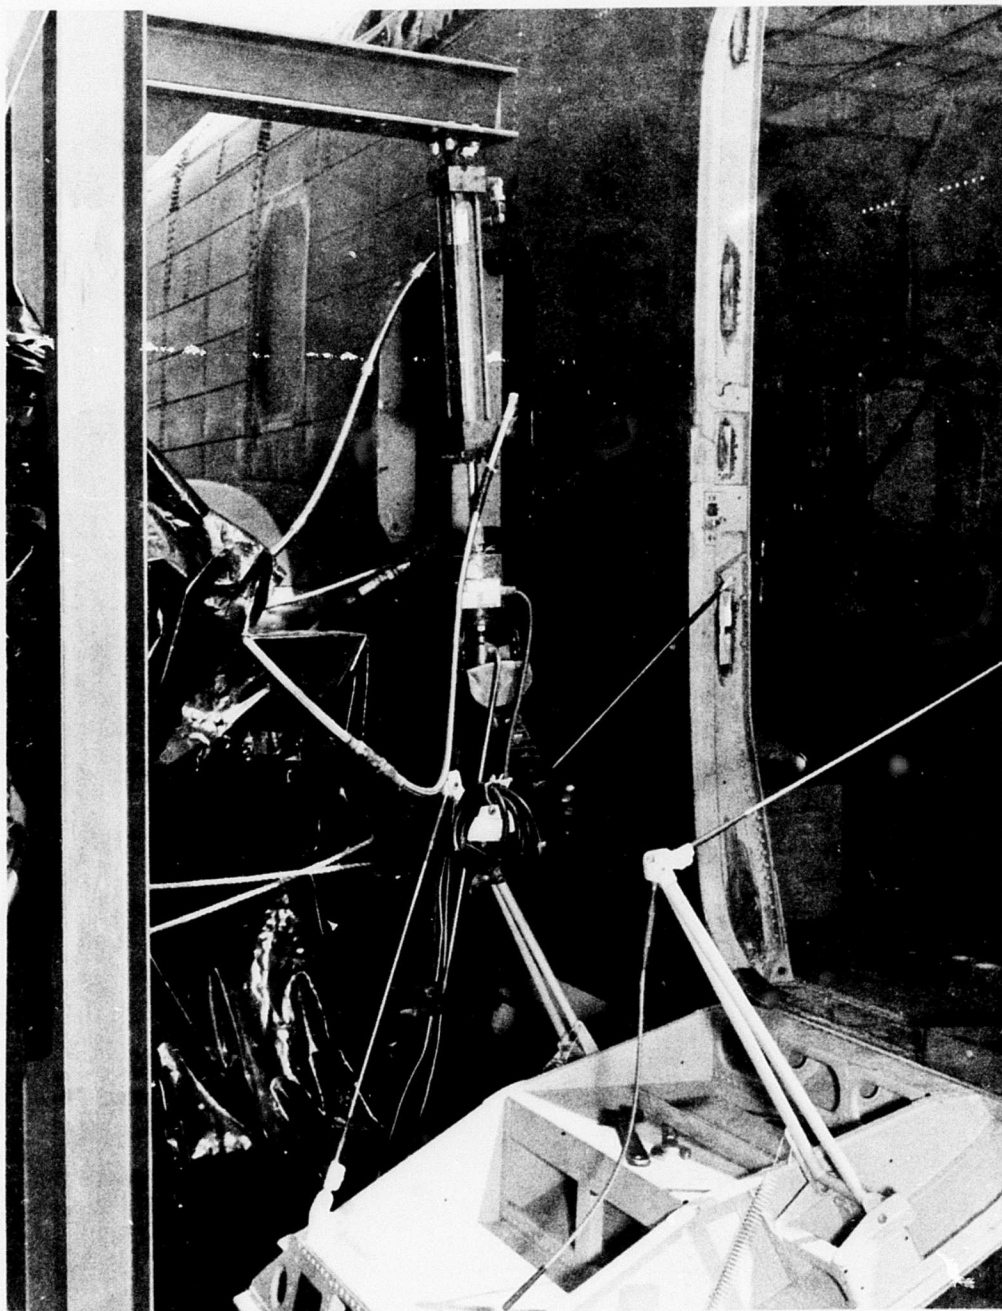
Figure 33. Lower Personnel Door, Cable Impacts.
